### Background

*Case performed by Dr Minas Leventis, PhD, UK*

## EARLY PLACEMENT CASE STUDY

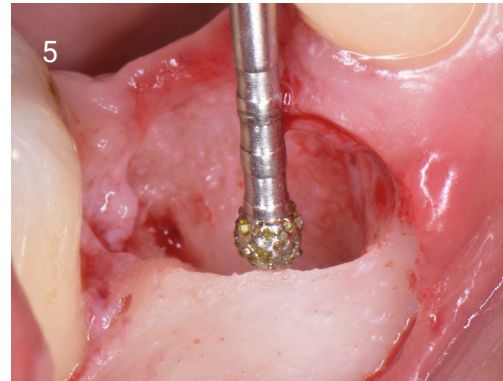
5. Debridement of the extraction socket. Degranulation burs used to remove all soft tissues and smooth socket walls.

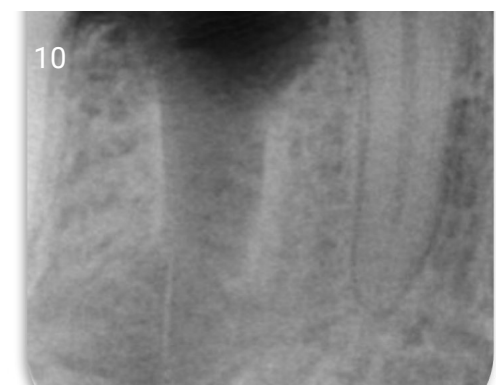
10. Periapical x-ray 1 month post-extraction.

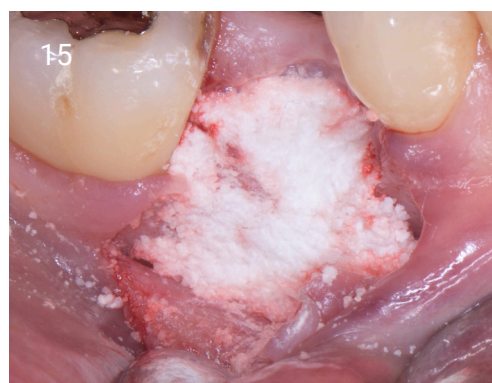
15. Grafted with EthOss<sup>®</sup>. No additional collagen membranes used.

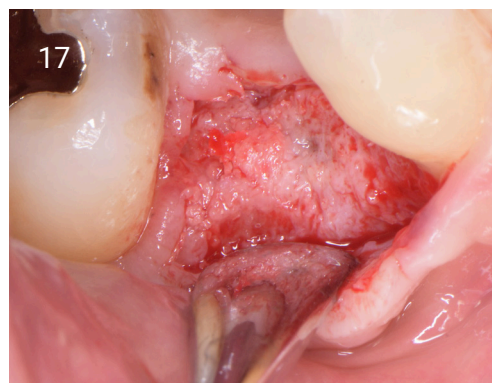
17. Surgical re-entry. After 3 months, the site was covered by newly formed regenerated bone.

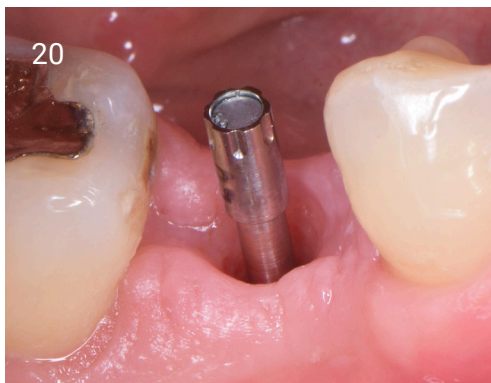
20. High ISQ measurement of 75 showing excellent secondary stability.

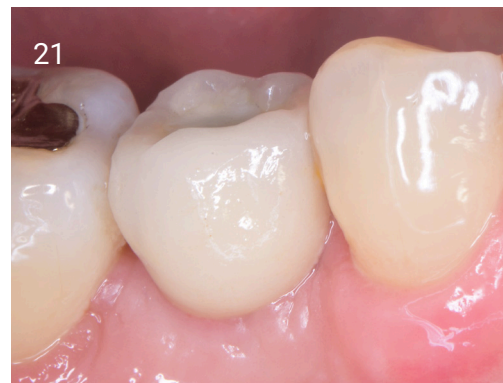
21. The implant was successfully restored with a screw-retained crown.
