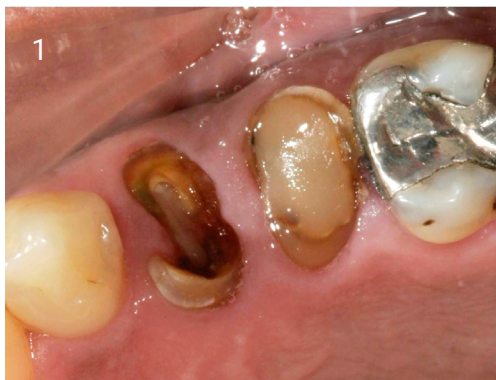
1. Failing 24 & 25 with chronic apical granulomas.

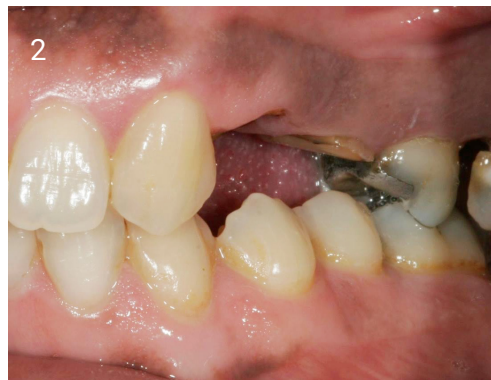
2. Buccal profile view.

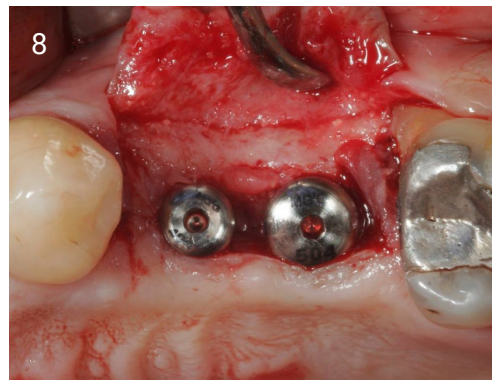
8. 4mm high healing abutments fitted. Image clearly shows a significant improvement in buccal bone width and profile.

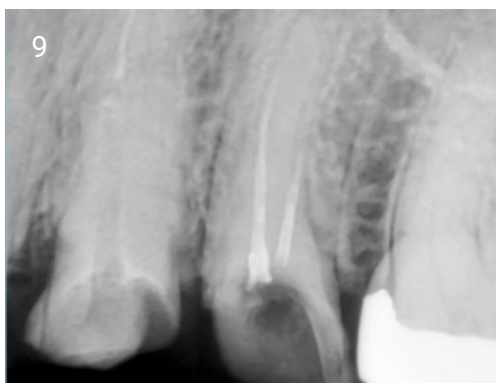
9. Pre-op radiograph.

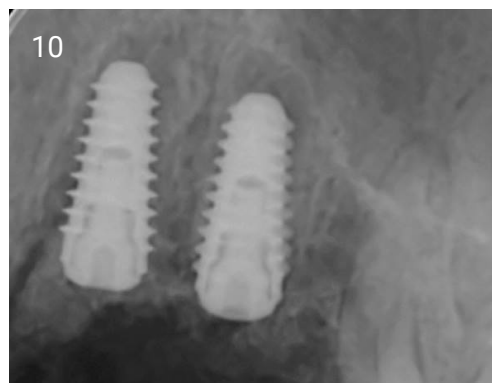
10. Immediate post-op radiograph.
