## Background

Fractured upper right second molar

## SOCKET GRAFT CASE STUDY

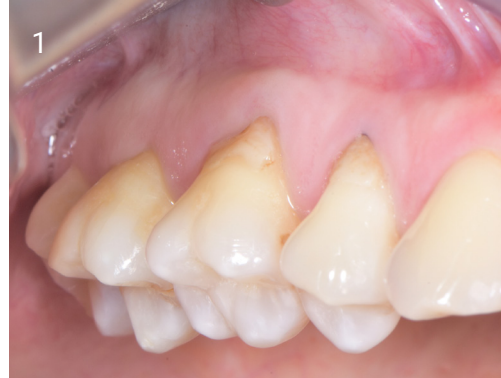
1. Vertical fracture of the upper right second molar.

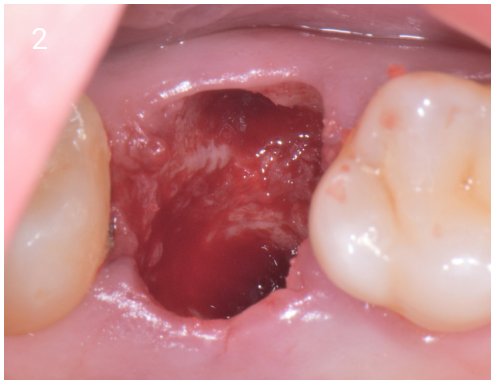
2. Fractured tooth extracted "atraumatically" under local anaesthesia.

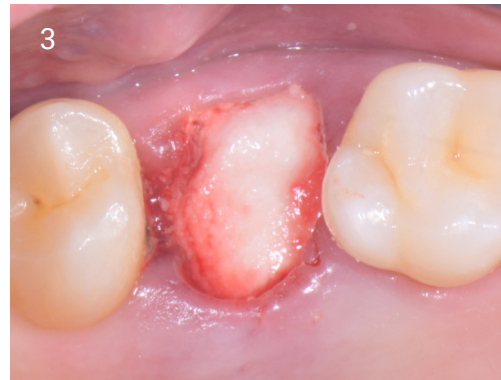
3. Socket grafting with EthOss®.

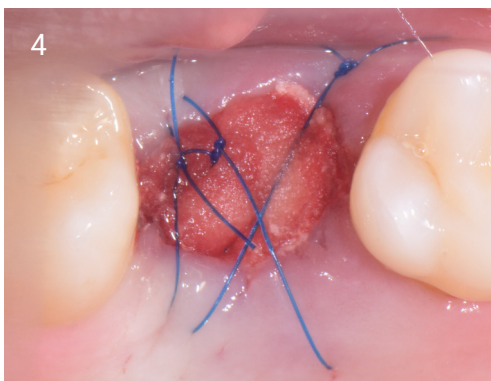
4. Covered with hemostatic collagen sponge, no primary closure.

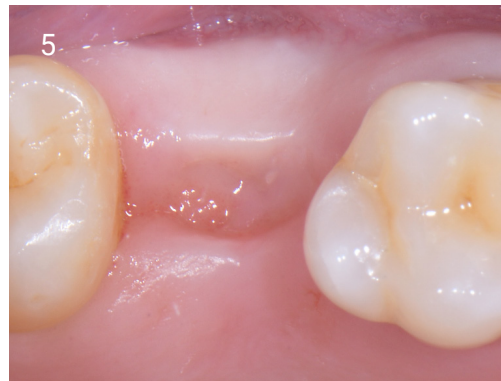
5. 12 weeks post-op.

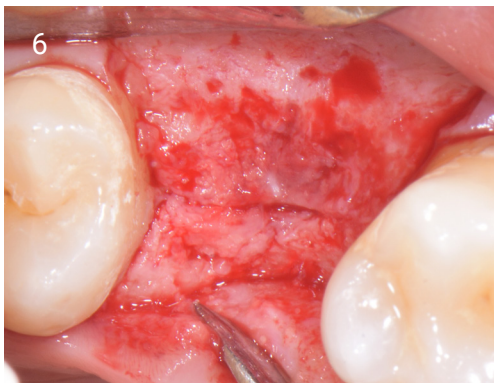
6. Re-entry at 12 weeks.

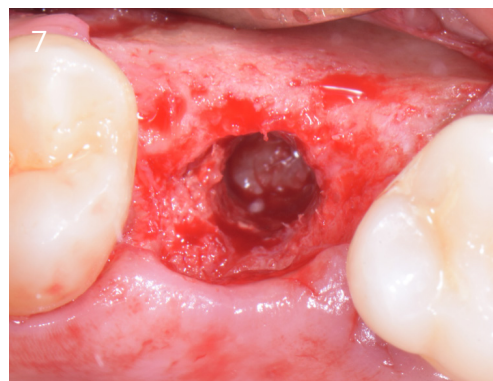
7. Bone biopsy and preparation for implant placement.

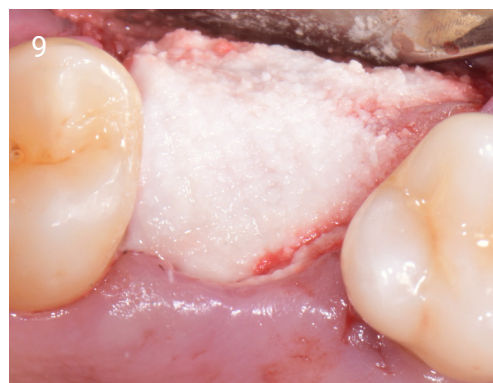
9. Additional grafting with EthOss®.

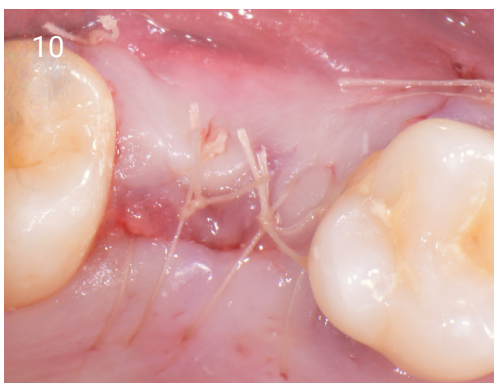
10. Tension-free closure.

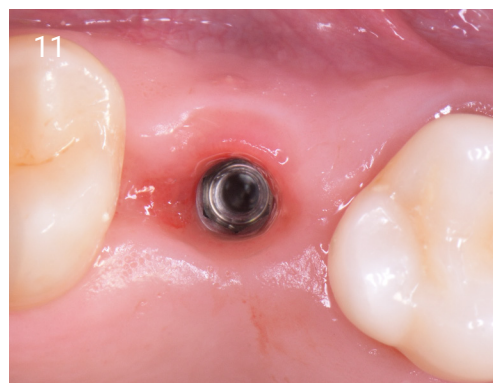
11. After 4 months.

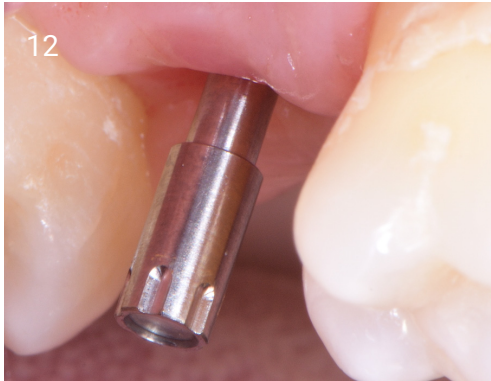
12. Penguin ISQ measurement: 74.

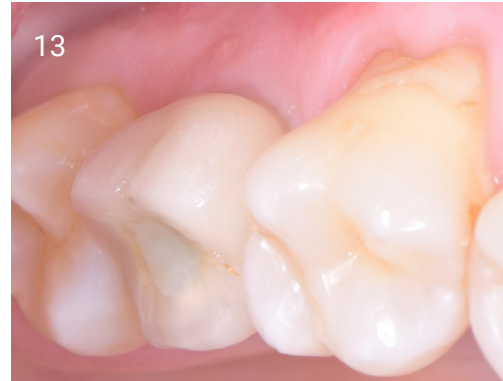
13. After fitting final screw-retained restoration. Outcome 7 months after initial socket grafting; 4 months after implant placement.

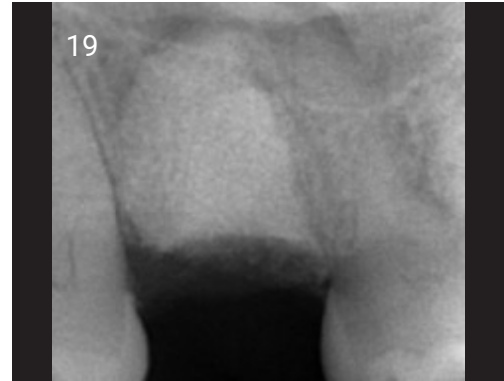
19. After extraction and socket grafting.

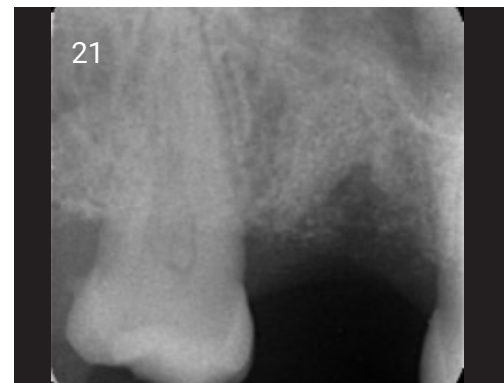
21. 12 weeks post-op.
