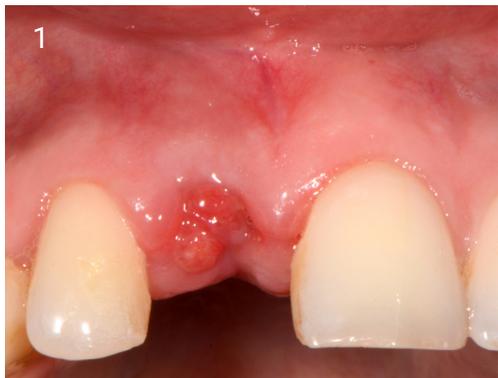
1. Pre-op view, 3 weeks following extraction to allow for soft tissue healing.

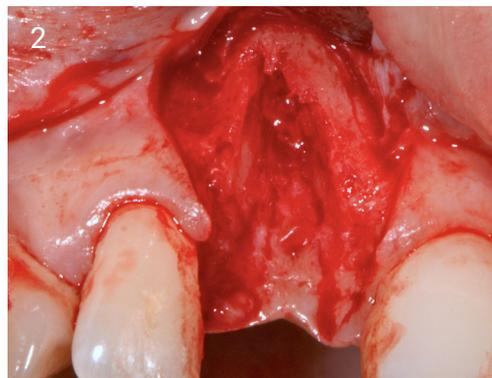
2. Site specific flap showing buccal defect.

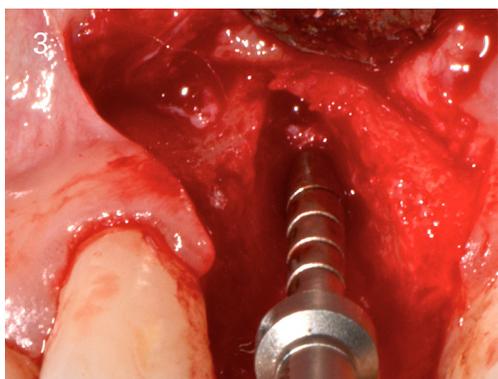
3. Defect with post to assess angle of placement.

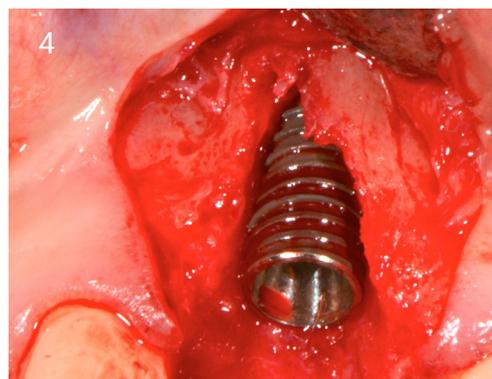
4. Placed implant showing the defect.

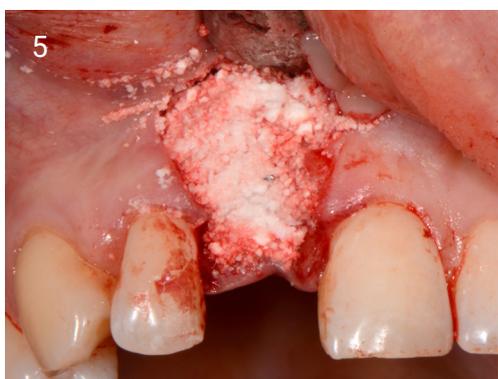
5. Grafted with EthOss<sup>®</sup> and set with sterile gauze.

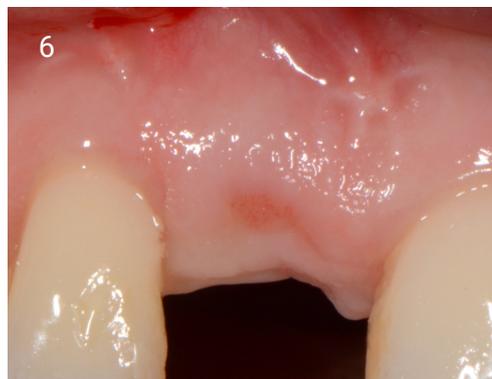
6. Healed site at 12 weeks.

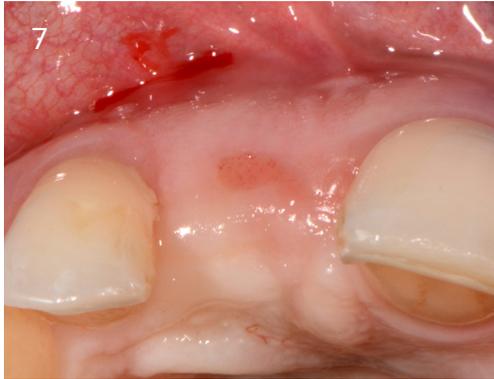
7. Healed site showing good soft tissue.

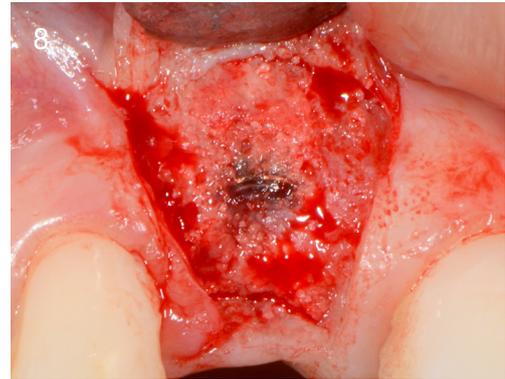
8. Flap raised showing the new true host bone.

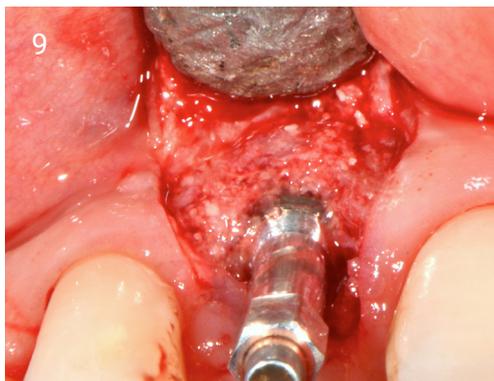
9. Osstell reading 75 ISQ.

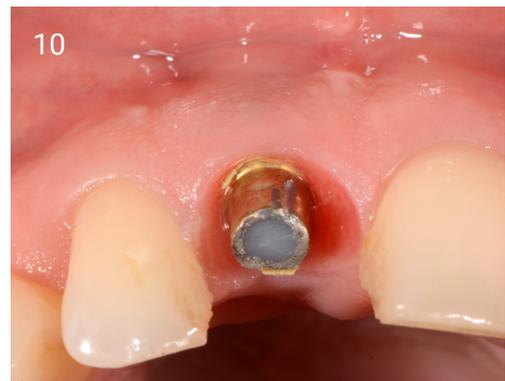
10. Recementation at 4 years showing retention of tissue volume long term.

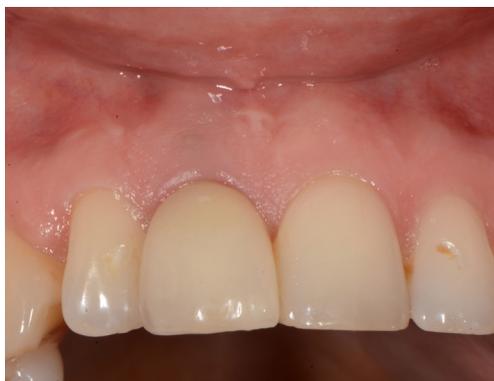
11. 4 years loaded showing tissue stability.

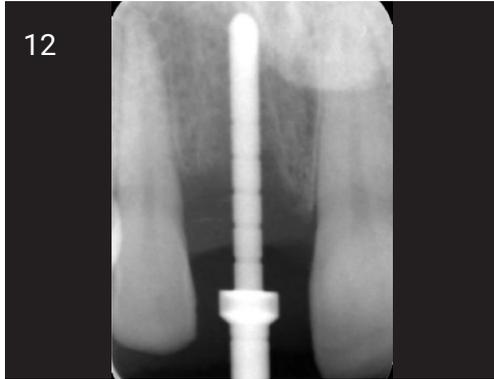
12. Radiograph of measuring post.

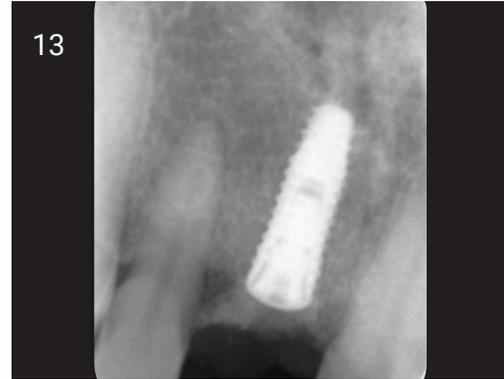
13. EthOss<sup>®</sup> set.

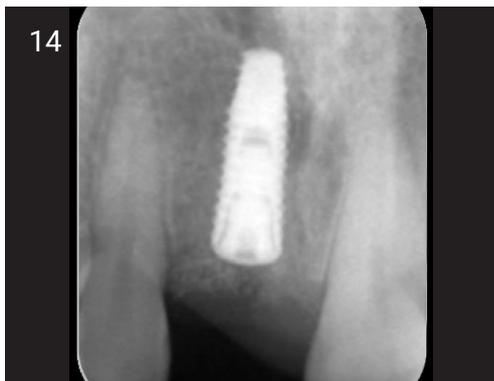
14. Radiograph of the healed new bone.

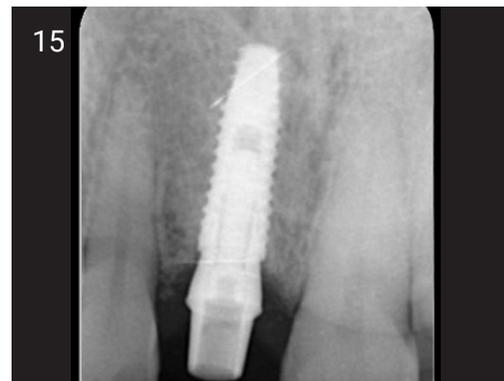
15. Radiograph at 4 years showing hard tissue stability.
