**Background**

*Case performed by Dr Michael Ainsworth, UK*

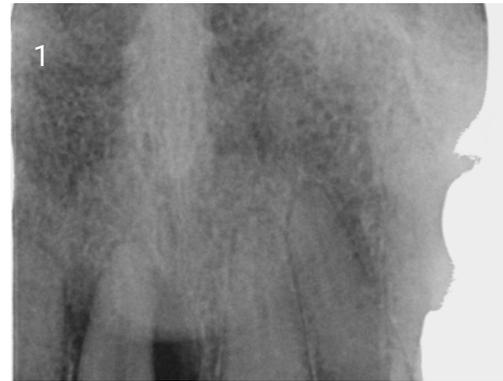
1. Initial situation. Periapical radiograph showing resorption.

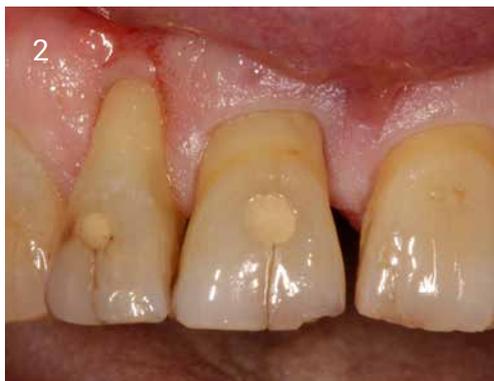
2. Examination revealed deep pocketing of up to 9mm mesially, grade 2 mobile, adjacent tooth grade 1 mobile and had pocket depth of 5mm distally.

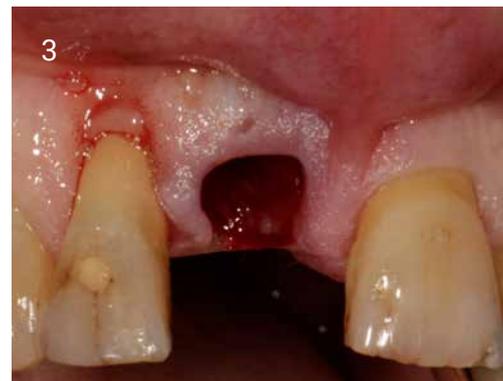
3. Atraumatic extraction leaving the socket epithelium intact.

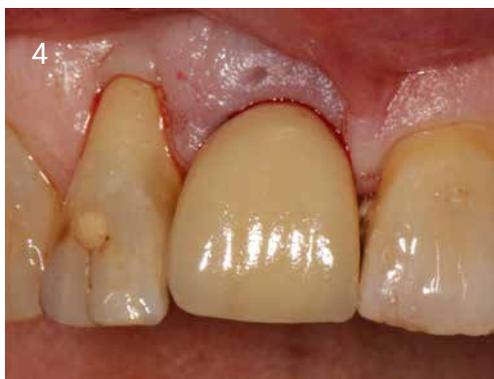
4. Maryland bridge, note close adaption and support of the socket periphery.

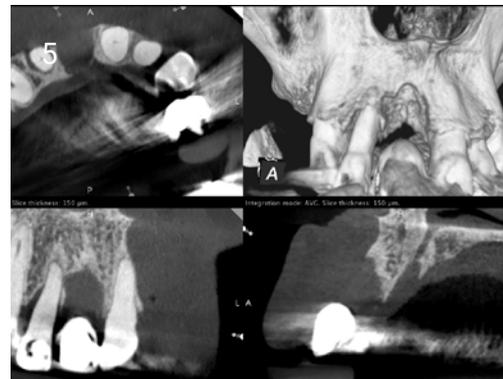
5. Two weeks following extraction – CBCT image of the extraction socket.

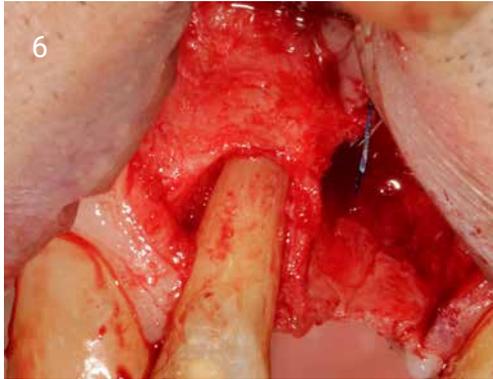
6. Four weeks following extraction – surgery, flap raised, completion of degranulation.

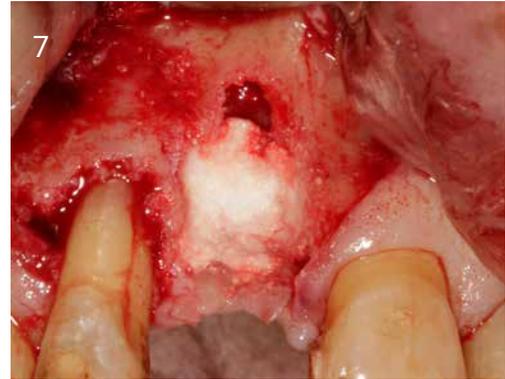
7. Palatal defect repair with EthOss<sup>®</sup>.

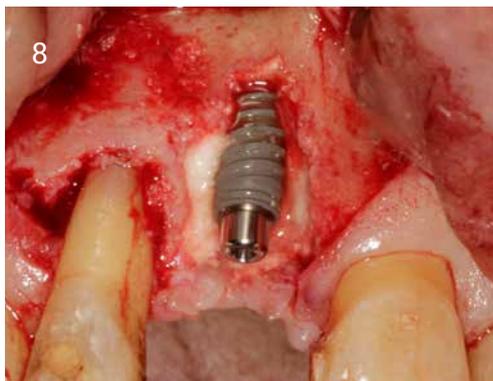
8. Implant placement with 2 mm cover screw.

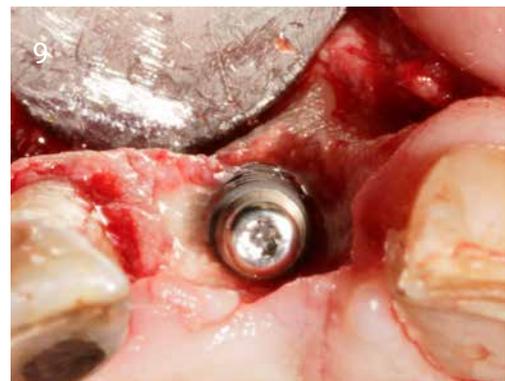
9. Implant placed in ideal position for cement-retained prosthesis.

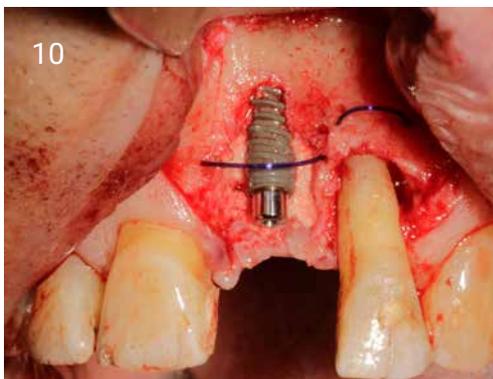
10. Placement of 2-0 PDS tenting sutures to create “dome device” to prevent micromovement of the graft material.

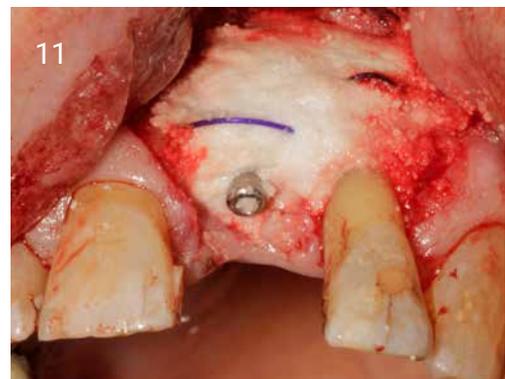
11. Placement of a “wetter” mixture of graft material in stages under the dome device, carefully drying and compressing with each stage.

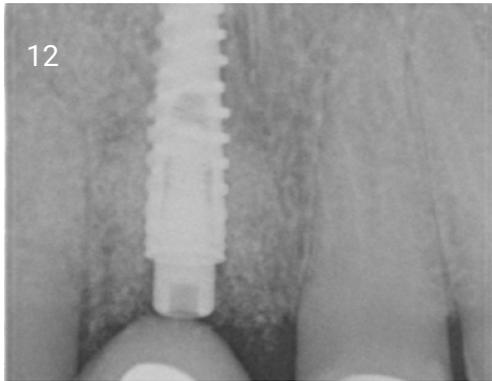
12. Control radiograph at twelve weeks healing.

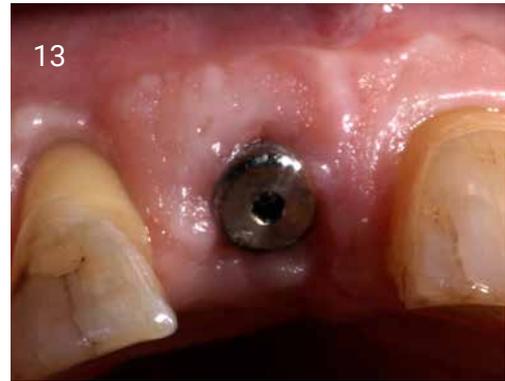
13. After two weeks healing post second stage.

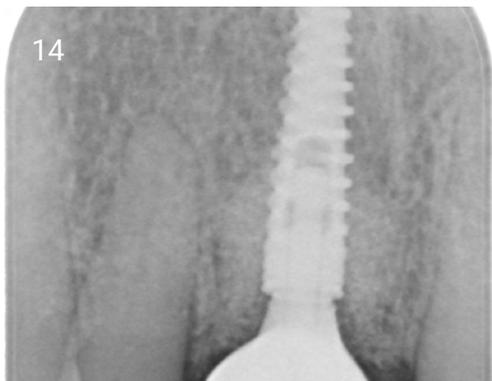
14. Twelve months control, following crown cementation.

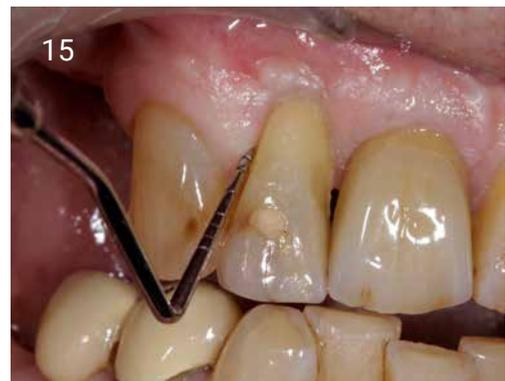
15. Probing the distal of tooth 12 shows 1 mm pocket depth indicating adequate healing response.

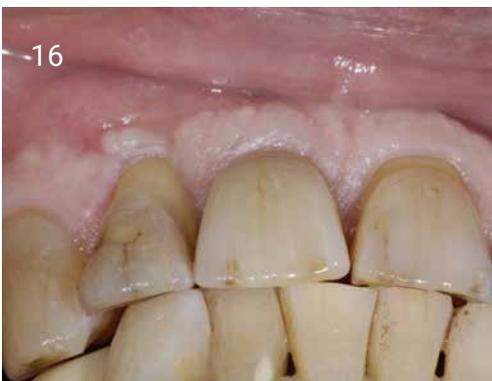
16. Final tissue maturation at twelve months, shows stippling, contour and volume consistent with underlying bone health.

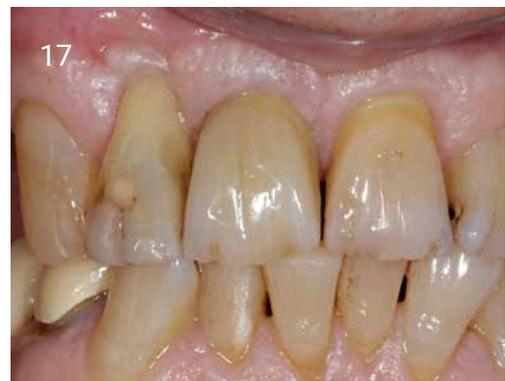
17. Final tissue maturation at twelve months, shows stippling, contour and volume consistent with underlying bone health.
