SOCKET GRAFT CASE STUDY

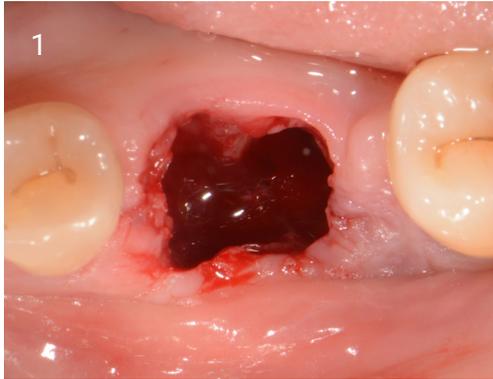
1. Extraction site infected and lost buccal plate. **N.B.** It is preferable to extract the tooth and leave the site for 3 weeks for soft tissue healing prior to grafting.

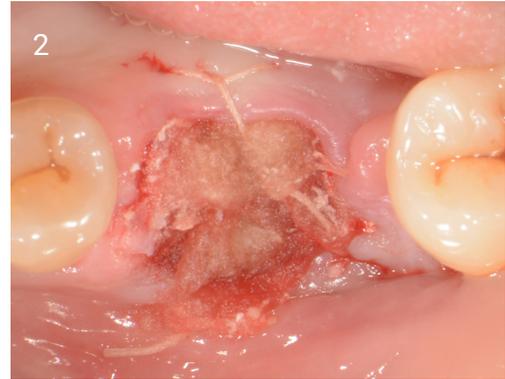
2. Grafted with EthOss®. Note buccal tissue shortage. Covered with fleece, cross-sutured with Vicryl 4.0.

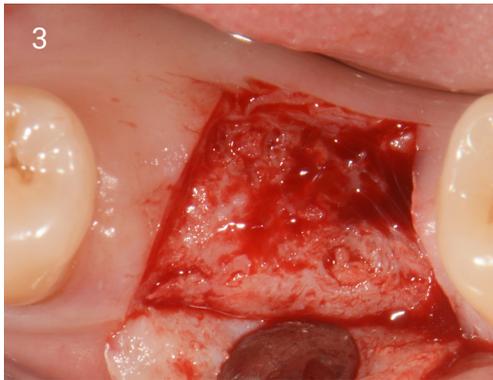
3. 10 weeks later, restored hard and soft tissue, note no Bucco-lingual volume loss.

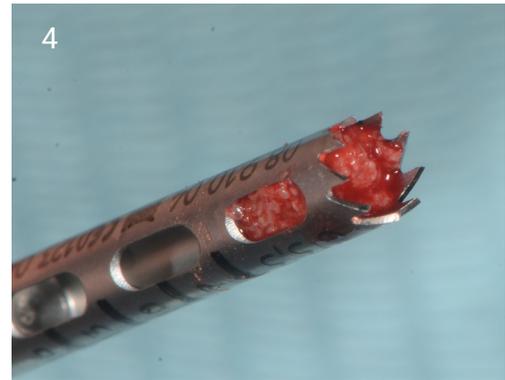
4. Core with new bone and residual graft.

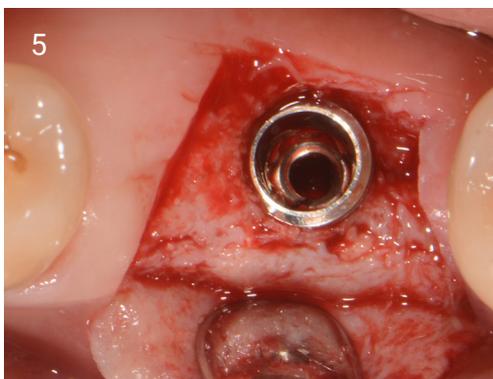
5. Implant placed 4.5 mm note good bone at 10 weeks.

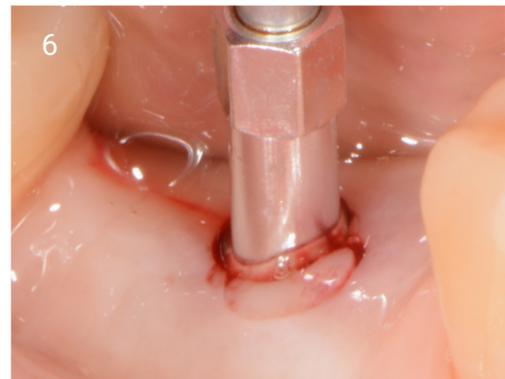
6. ISQ reading of 69 at 10 weeks, implant only in grafted site bone. ISQ reading of 77 at 3 months, a sign of strong osseointegration.

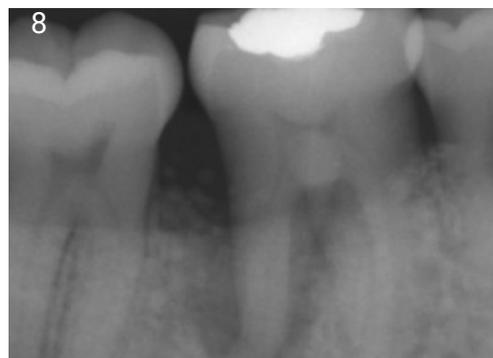
8. Infected tooth.

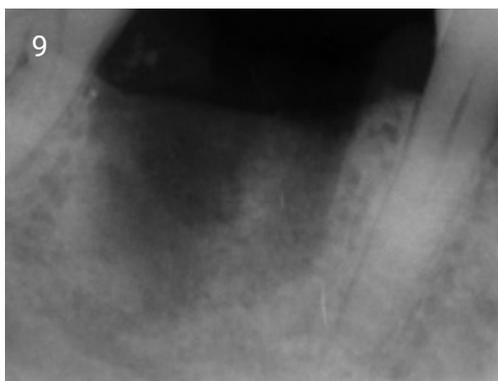
9. Extraction site showing bone loss.

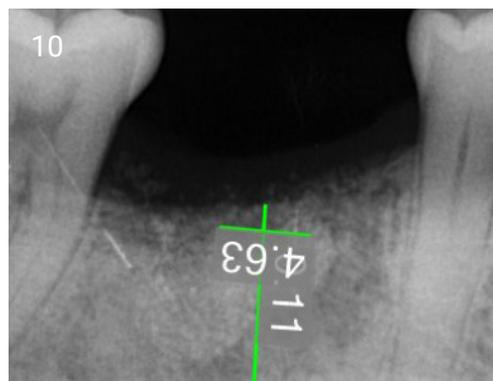
10. 10 weeks showing new bone level.

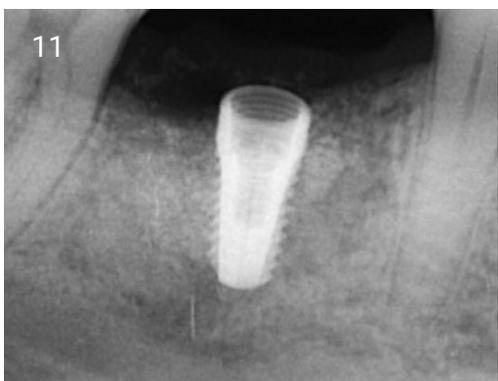
11. Implant placed into the site

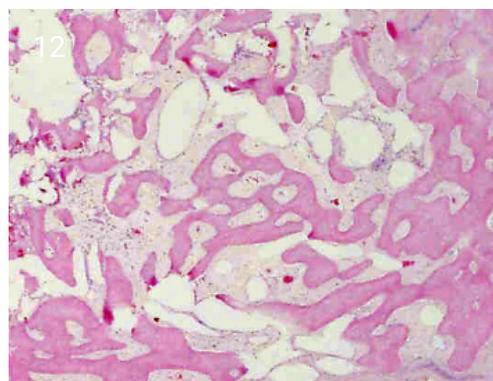
12. Photomicrograph of Biopsy at 10 weeks showing significant amount of new bone growth surrounding EthOss® particles.
