Background

UR1 extracted due to lack of coronal tooth tissue available to crown. Root was dehiscence buccally at the apical portion, leaving the extraction socket not having buccal bone intact. Root was extracted, and the implant placed at 6 weeks.

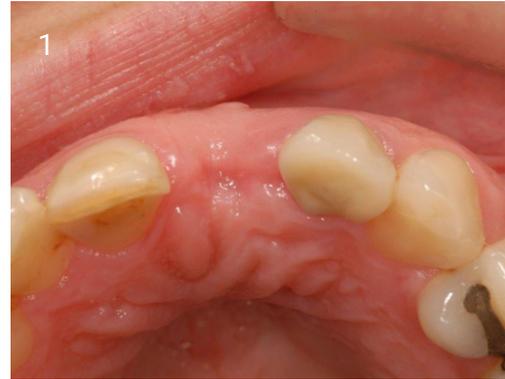
1. Buccal view pre-surgery.

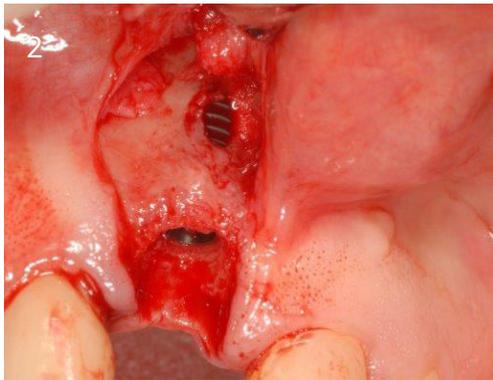
2. Implant in position showing defect.

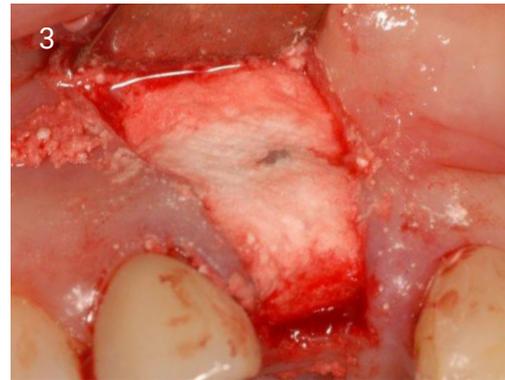
3. EthOss® placed.

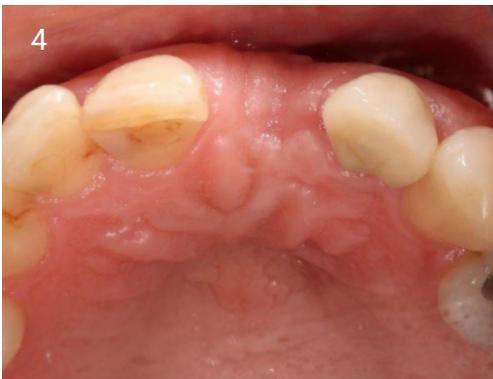
4. Buccal view of healed site at 16 weeks.

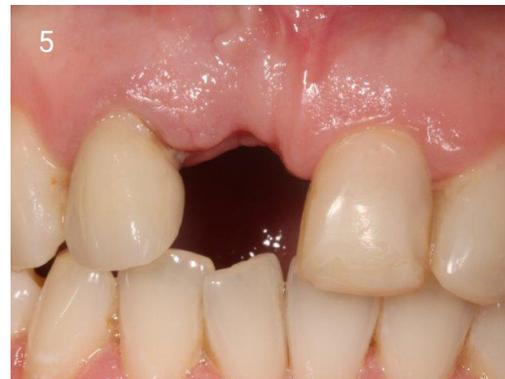
5. Healed site at 16 weeks.

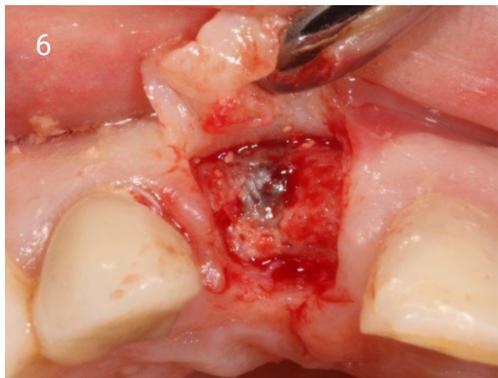
6. Exposure showing bone growth over implant no relief to preserve the gingival blood supply.

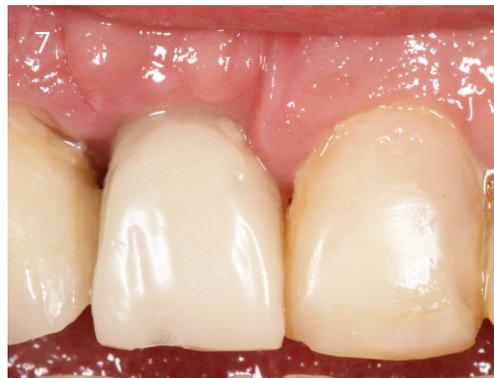
7. Fit of temporary tooth to allow gingival maturation.

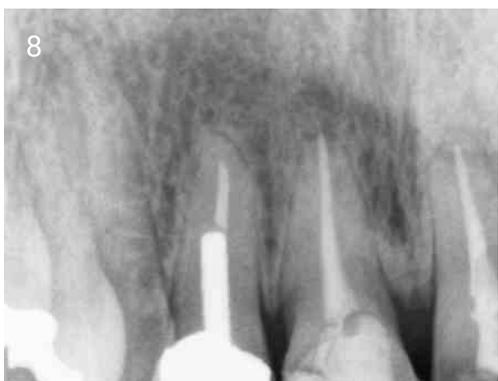
8. Pre-extraction periapical radiograph.

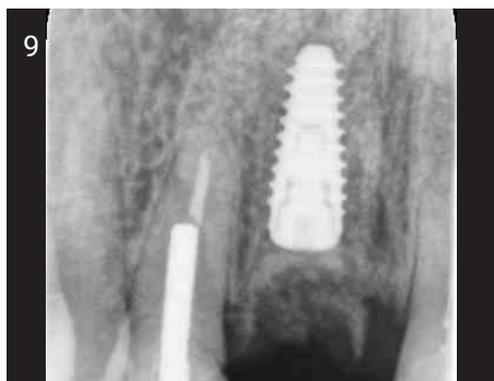
9. Post implant placement periapical radiograph.
