## UPPER LEFT 4 CASE STUDY

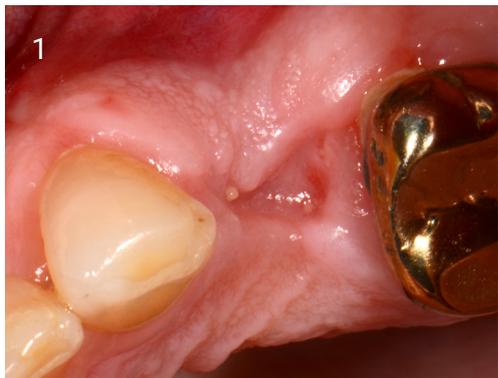
1. 3 weeks post extraction healing, bone and profile loss.

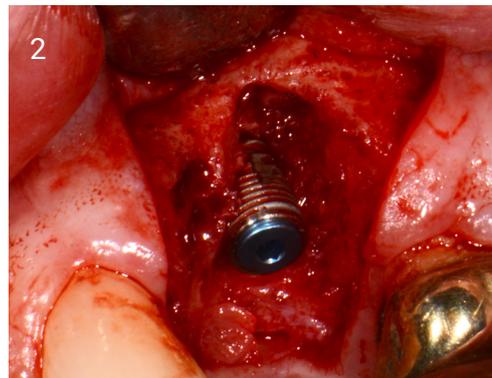
2. Implant placed. Osstell reading taken at placement: 51 ISQ.

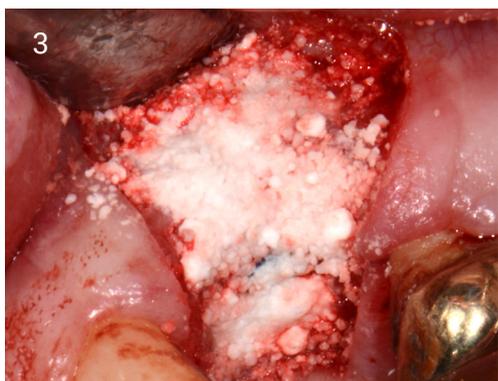
3. Grafted with EthOss®.

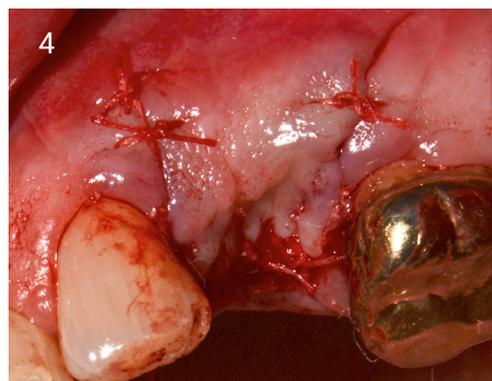
4. Sutured closed.

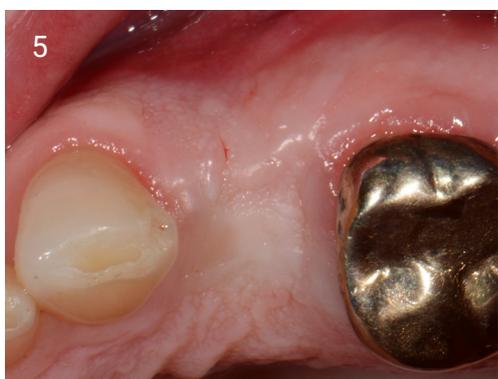
5. Healed site at 12 weeks.

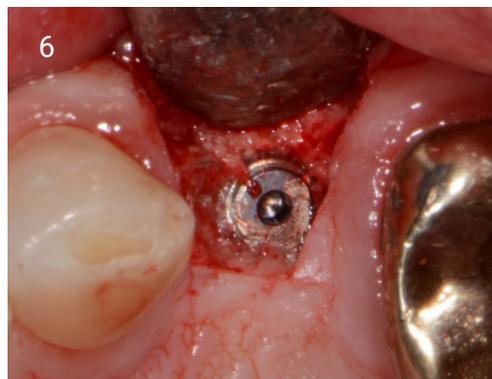
6. Raised flap to show new hard tissue.

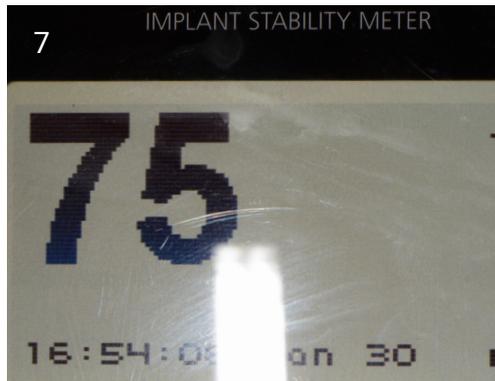
7. Osstell now 75 ISQ showing integration.

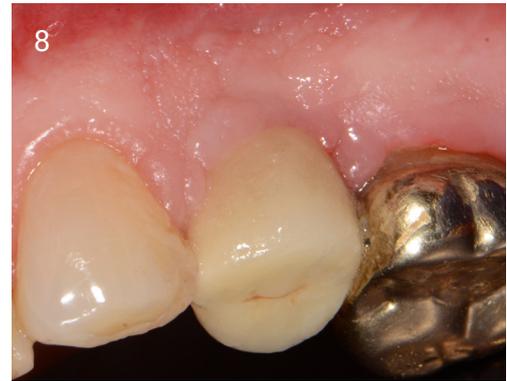
8. 2 years loaded.

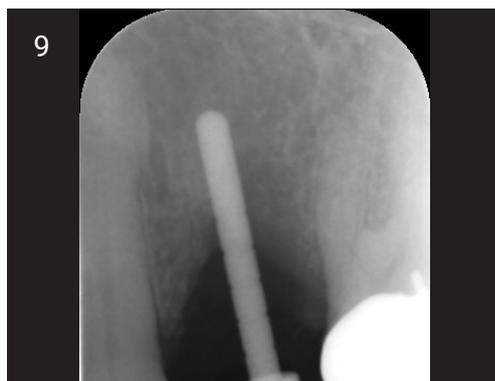
9. Pilot bur showing bone loss.

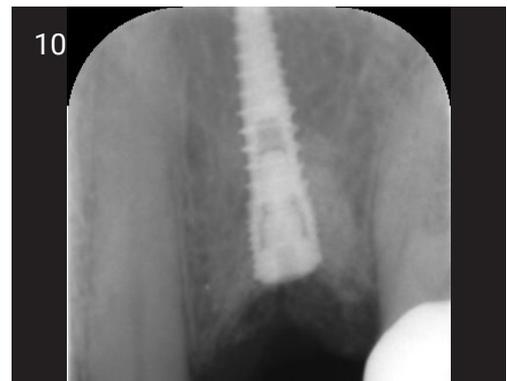
10. Implant placed and site grafted.

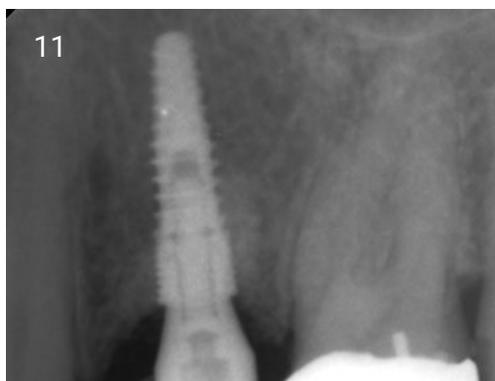
11. 12 weeks healed site loaded.

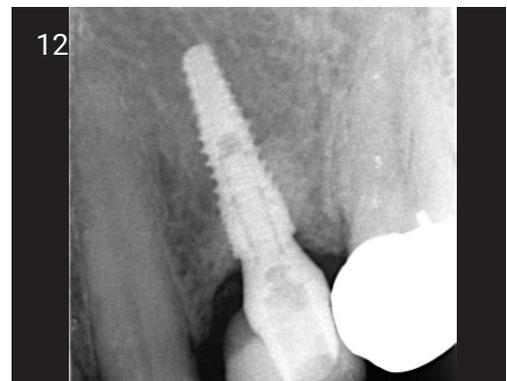
12. Loaded 2 years.
