**Case Study Originally
Printed in European
Journal for Dental
Implantologists, 4/2014
pp 58 - 62.**

Case by Dr Peter Fairbairn,
London, UK

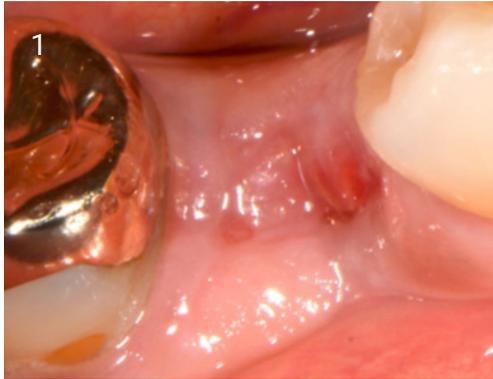
1. Lower right second premolar site at 3 weeks post extraction.

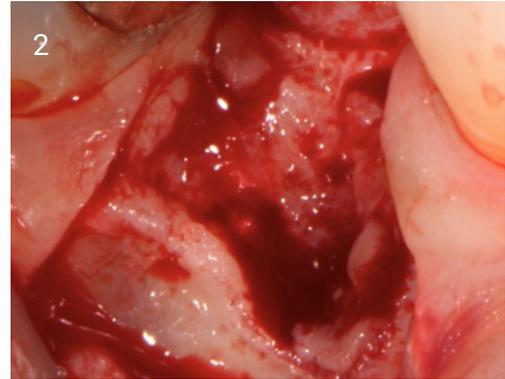
2. Site specific flap retaining the papillae, showing bone loss due to split root.

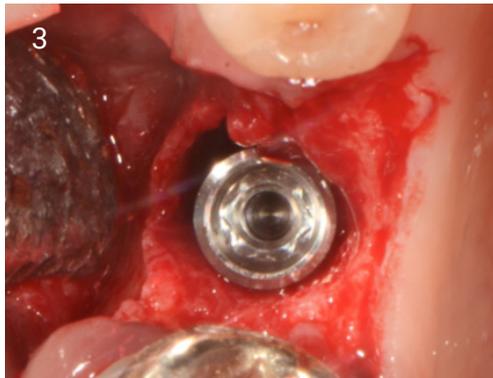
3. Implant placed in best position ready for grafting.

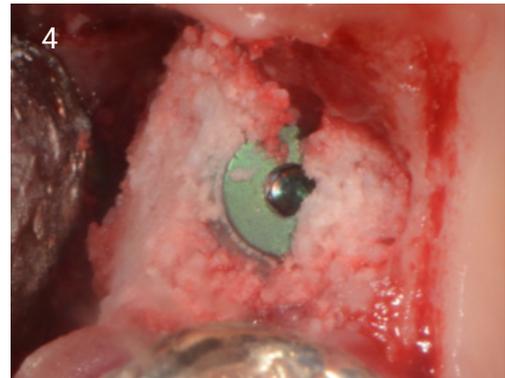
4. Buccal graft with EthOss® to regenerate bone.

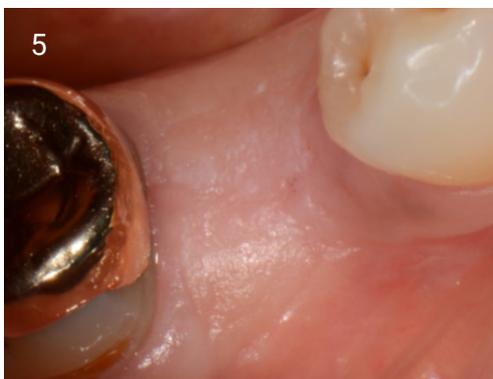
5. Good soft tissue healing at 10 weeks and restoration of the ridge.

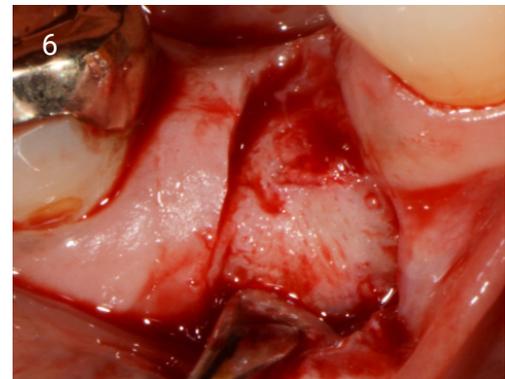
6. Flap raised to show newly regenerated bone at 10 weeks.

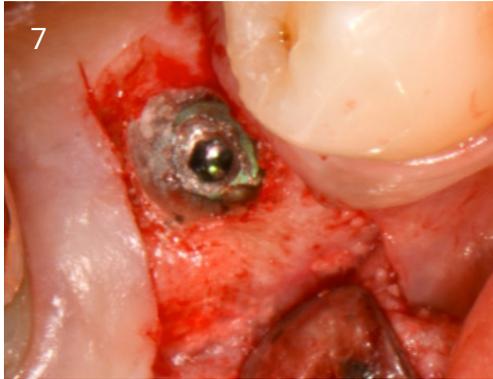
7. Site of core sample.

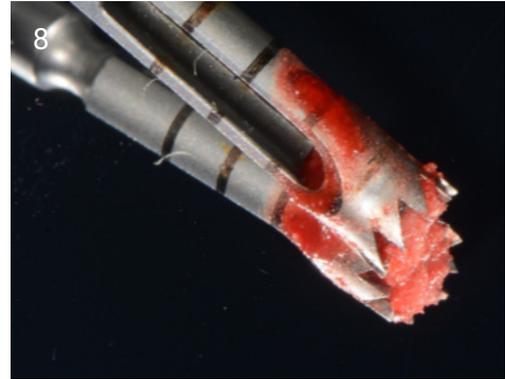
8. Core sample taken above the implant to gain access, sent for Histologic analysis.

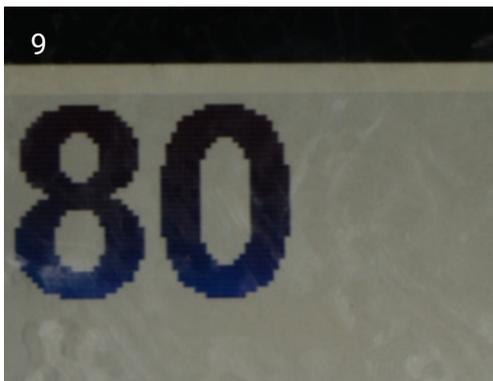
9. Osstell meter reading at loading.

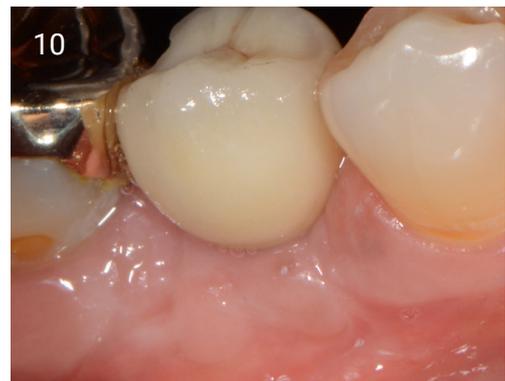
10. Case at 6 months.

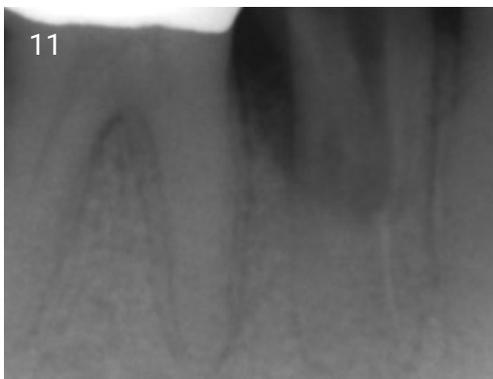
11. Radiograph showing split root and resultant bone loss.

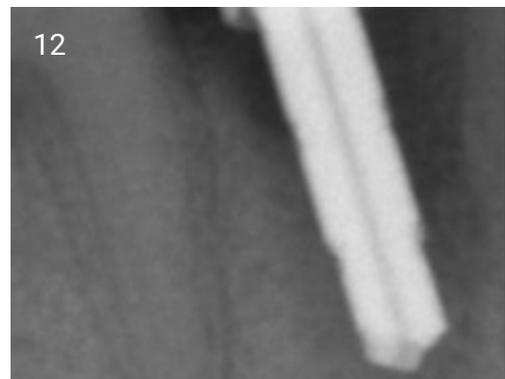
12. Radiograph of osteotomy creation.

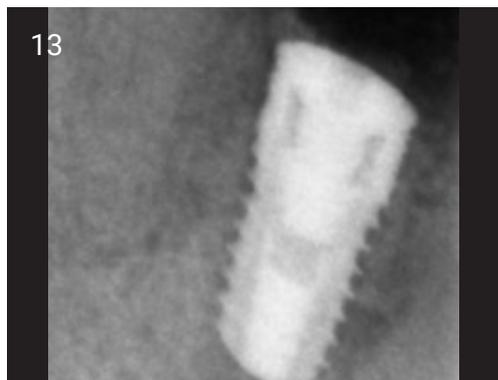
13. Radiograph of placed implant with graft material.

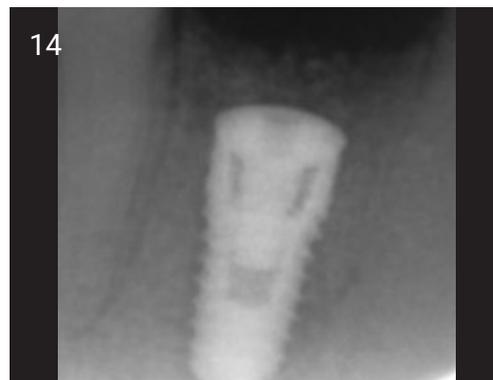
14. Radiograph at 10 weeks post placement showing raised bone level.

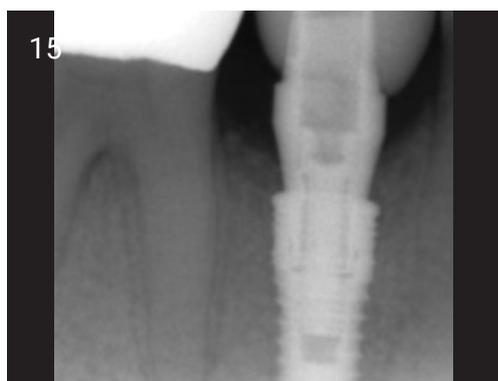
15. Radiograph at 6 months.

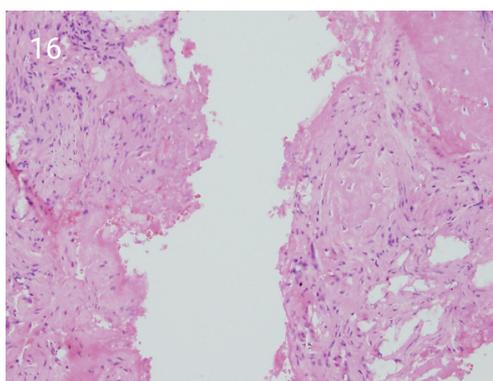
16. Histology by Prof. David Mangham, University of Birmingham, UK, showing approximately 50% (overall) induced woven bone.
