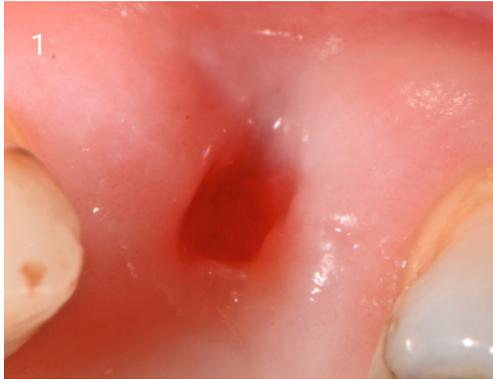
1. 3 weeks post extraction. Soft tissue healing.

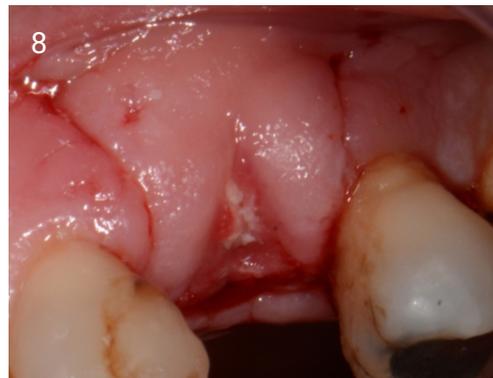
8. After 5 days at suture removal, improved profile.

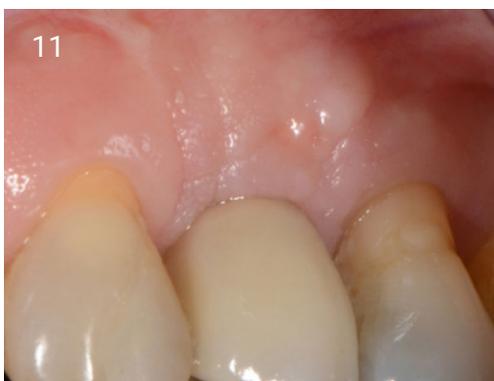
11. Loading with an E-max crown.

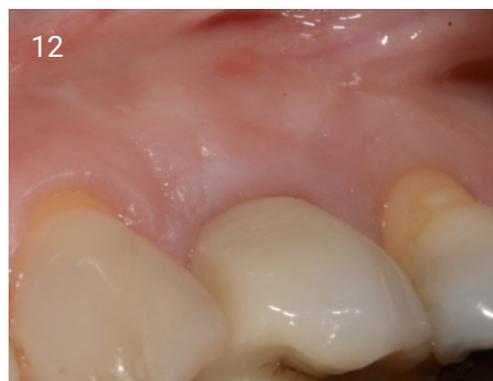
12. Loaded 1 year, good attached gingiva.

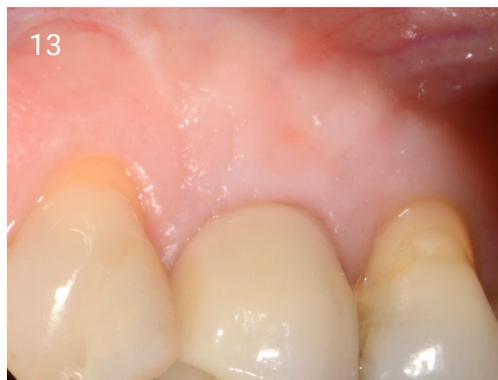
13. Close up of soft tissue aesthetics.

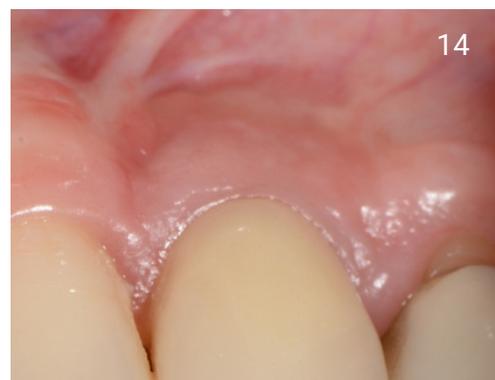
14. Loaded 2 years, showing retention of tissue both hard and soft, functional loading.

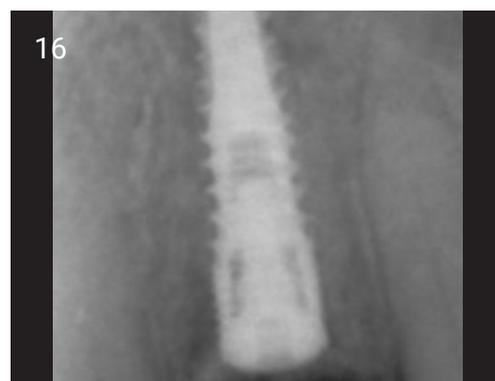
16. Radiograph showing graft.

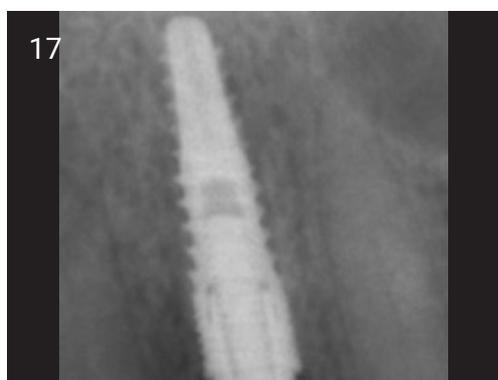
17. Radiograph at loading.
